5.4.2 GROUND FAILURE

This section provides a profile and vulnerability assessment for the ground failure hazard, including landslides, land subsidence, and sinkholes.

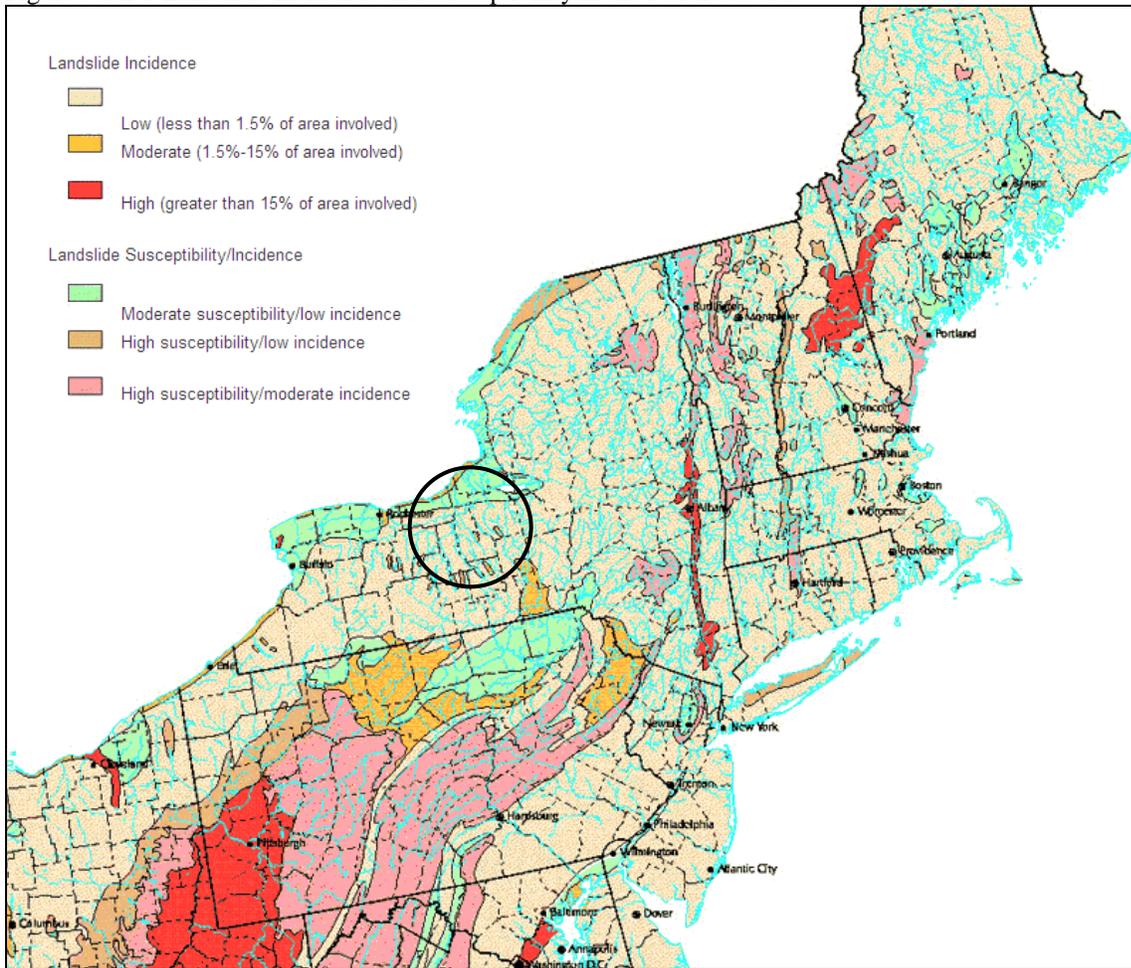
Figure 5.4.2-1 Landslide Incidence and Susceptibility in the Northeast U.S.

Note: The circle indicates the approximate location of Cayuga County.

Figure 5.4.2-1 depicts the landslide incidence and susceptibility of the northeastern U.S., identifying areas that have the potential for landslides. These areas are determined by correlating some of the principal factors that contribute to landsliding, such as steep slopes, weak geologic units that lose strength when saturated, and poorly drained rock or soil, with the past distribution of landslides.

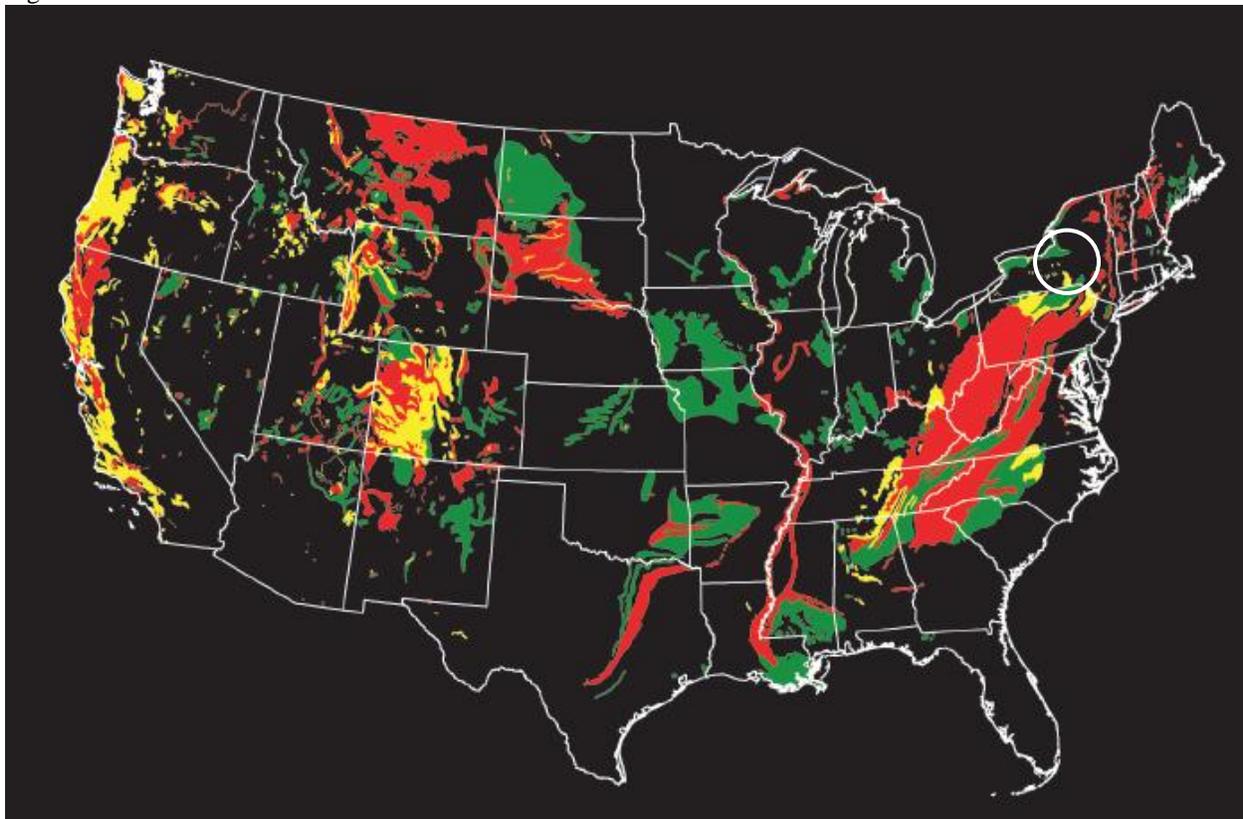
Figure 5.4.2-2 Landslide Potential of the Conterminous U.S.

Note: Red areas have very high potential, yellow areas have high potential, and green areas have moderate potential. Landslides can and do occur in the black areas, but the potential is low. Map not to scale. Circle indicates the approximate location of Cayuga County.

The entire U.S. experiences landslides, with 36 states having moderate to highly severe landslide hazards. Expansion of urban and recreational developments into hillside areas leads to more people being threatened by landslides each year (USGS, 2011). Figure 5.4.2-2 illustrates the potential for landslides in the U.S.

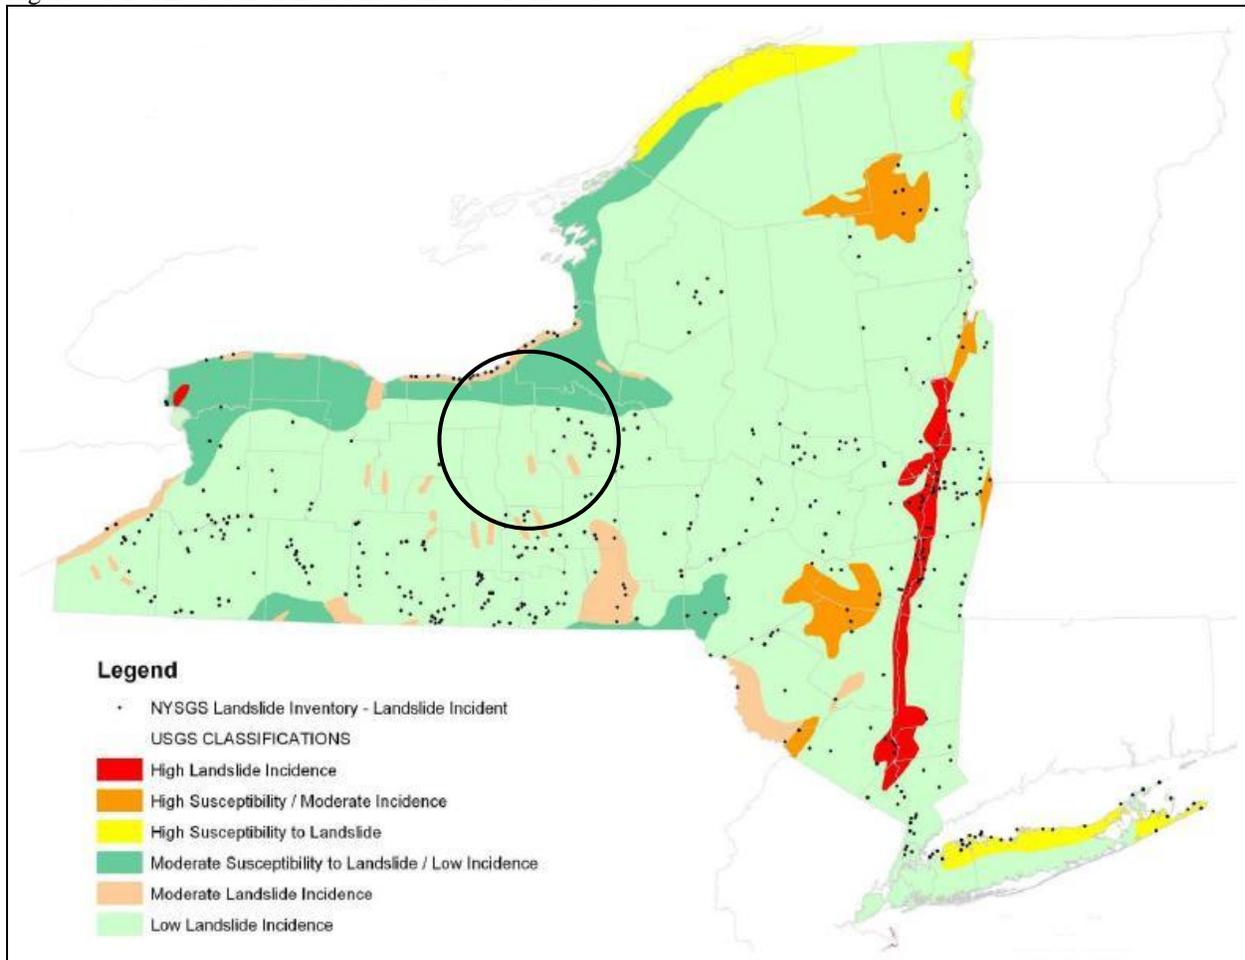
Figure 5.4.2-4 Location of Landslides in New York State.

Note: The circle indicates the approximate location of Cayuga County. The NYS HMP indicates that Cayuga County has not had any landslide occurrences from 1837 to 2007.

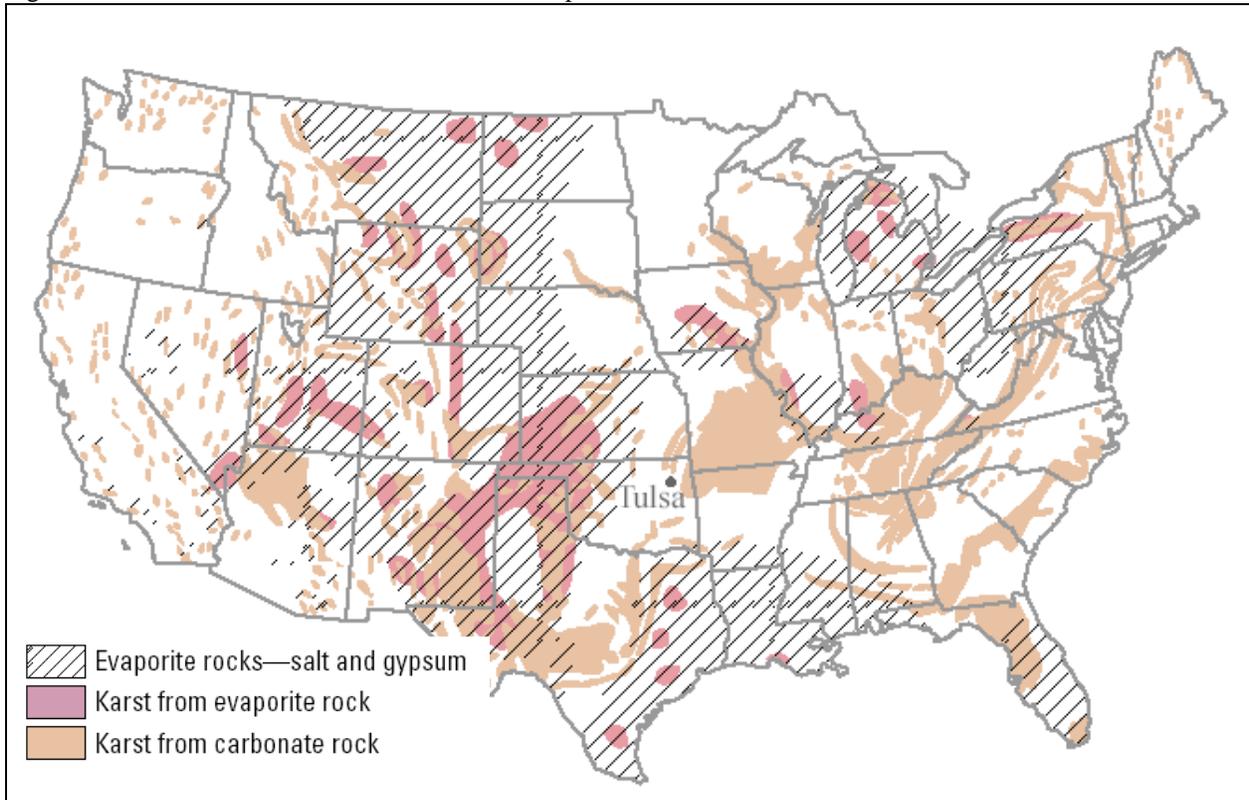
Figure 5.4.2-5 Subsidence Due to Sinkholes and Evaporative Rock

Note: Salt and gypsum underlie about 40% of the contiguous U.S. Carbonate karst landscapes constitute about 40% of the U.S. east of Tulsa, OK.

There is an additional area of karstic materials not shown on this map. In areas where the Tully Limestone is near the ground surface, conditions exist for the dissolution of carbonates within the limestone. This has led to numerous disappearing streams existing in Moravia, Ledyard, and Genoa. These disappearing streams can contribute to flash flooding, sinkhole formation and drinking water contamination (County Input, 2013).

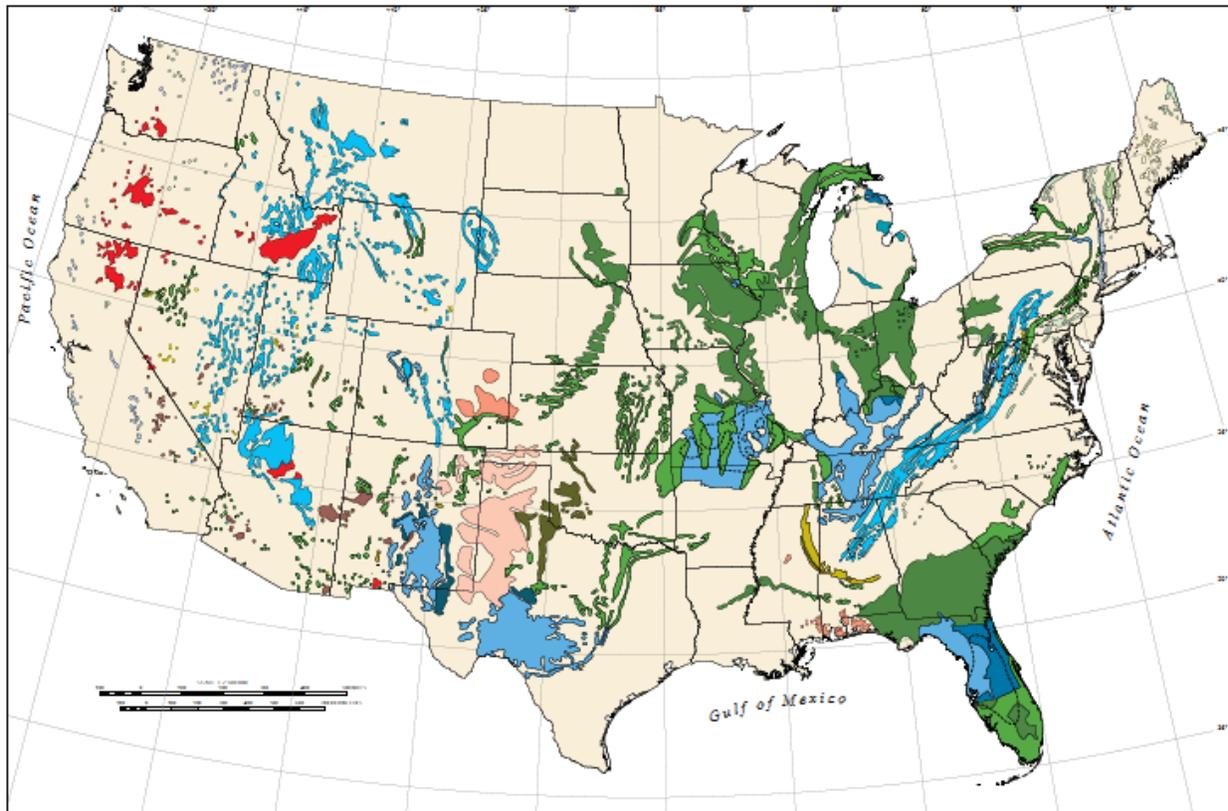
Figure 5.4.2-6 Karst Areas across the U.S.

Carbonate rock (limestone and dolomite) is also prone to void formation, but over a much longer period of time that evaporite rock. Also, the presence of glacial till in many areas of the State seems to prevent sudden collapses in carbonate rock. As a result, collapses are relatively rare in New York, even in the regions characterized by karst topography (NYS HMP, 2011). Figure 5.4.2-6 illustrates the karst environments across the U.S.

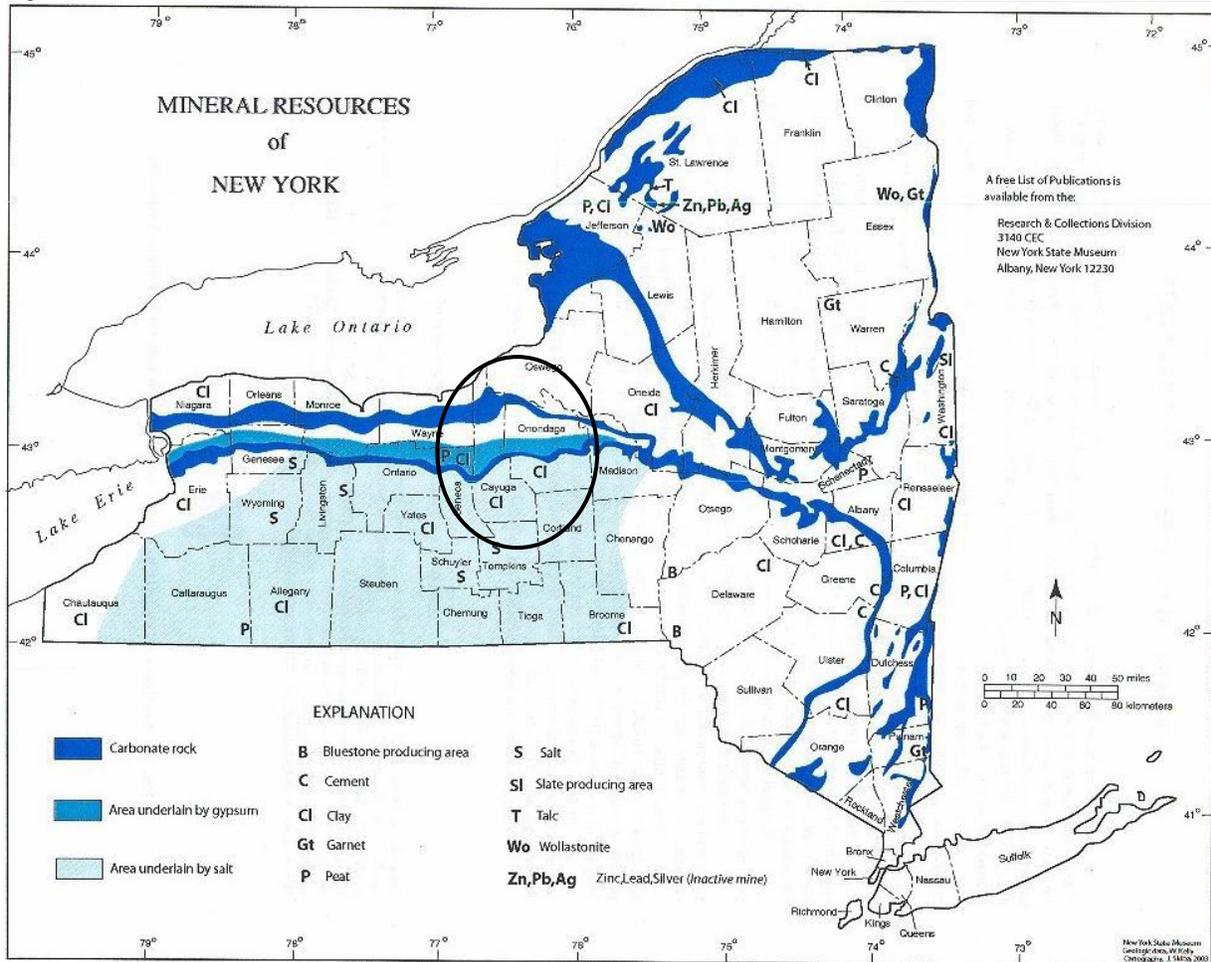
Figure 5.4.2-7 Mineral Resources of New York State.

Note: The circle indicates the location of Cayuga County

Figure 5.4.2-7, below, was created by the NYSGS to emulate the USGS map showing the location of rock type and minerals that are generally susceptible to natural land subsidence. Locating mineral resources helps to indicate areas where the potential exists for human caused land subsidence due to mining collapse, which is often cited as a causal element of land subsidence (NYS HMP, 2011).

Salt and gypsum are abundant across western and central New York State, including southern Cayuga County, and a number of underground salt and gypsum mines exist in this part of the State. This figure also indicates mining in Cayuga County, including clay mines in the southern part.

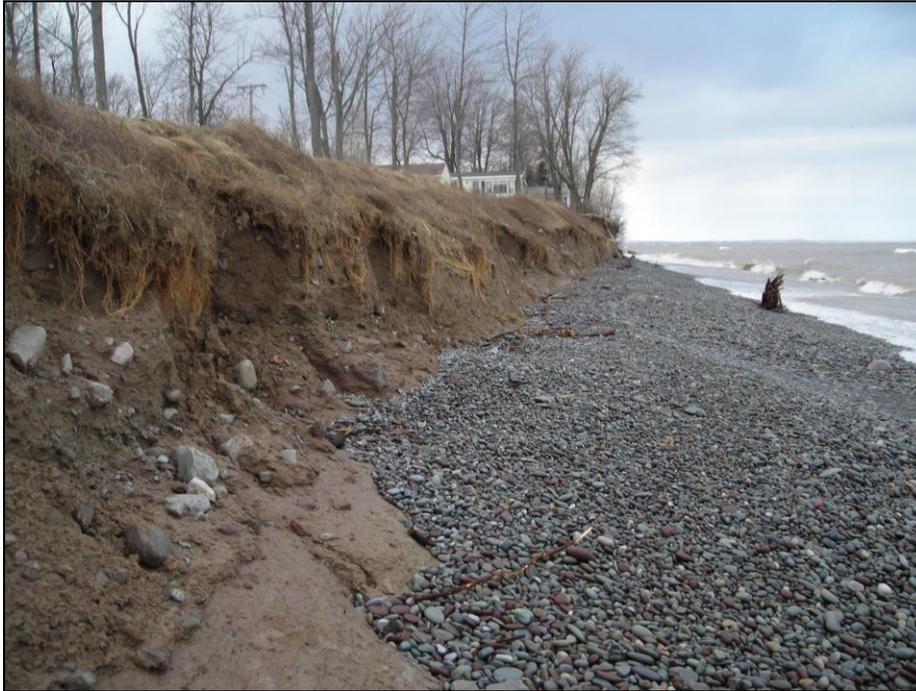
Figure 5.4.2-8 February 2003 Landslide Event, Moon Beach (Town of Sterling)

The Lake Ontario shoreline is vulnerable to collapse due to constant wind, wave and winter ice action against the deep sandy soils. Cayuga County’s eight miles of Lake Ontario shoreline is roughly 60% County and state parkland with about 1.4 miles of residential development. The State rated the coastal erosion rates in 1989 in the “Coastal Erosion Hazard Area Map, Town of Sterling, Cayuga County.” Over the past 20 years, lakeshore landslides have destroyed about ten homes and/or summer cottages in the Moon Beach hamlet in Sterling. At least eight additional homes and a half-mile of Town road remain very vulnerable for future landslides (County Input, 2013). Figures Figure 5.4.2-8 through Figure 5.4.2-10 show the effects of this landslide event.

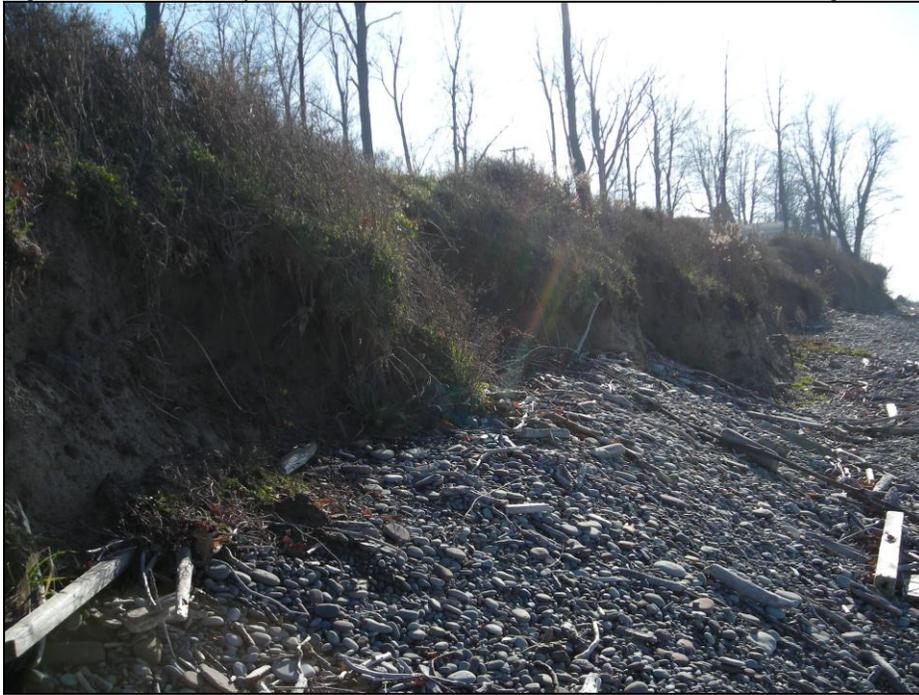
Figure 5.4.2-9 February 2003 Landslide Event, Moon Beach (Town of Sterling)

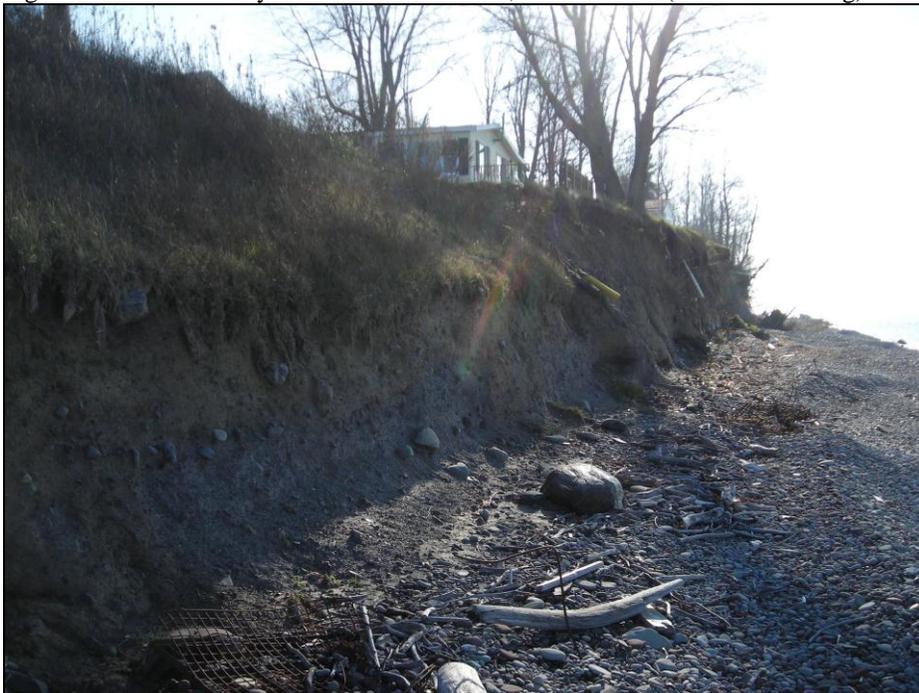
Figure 5.4.2-10 February 2003 Landslide Event, Moon Beach (Town of Sterling)

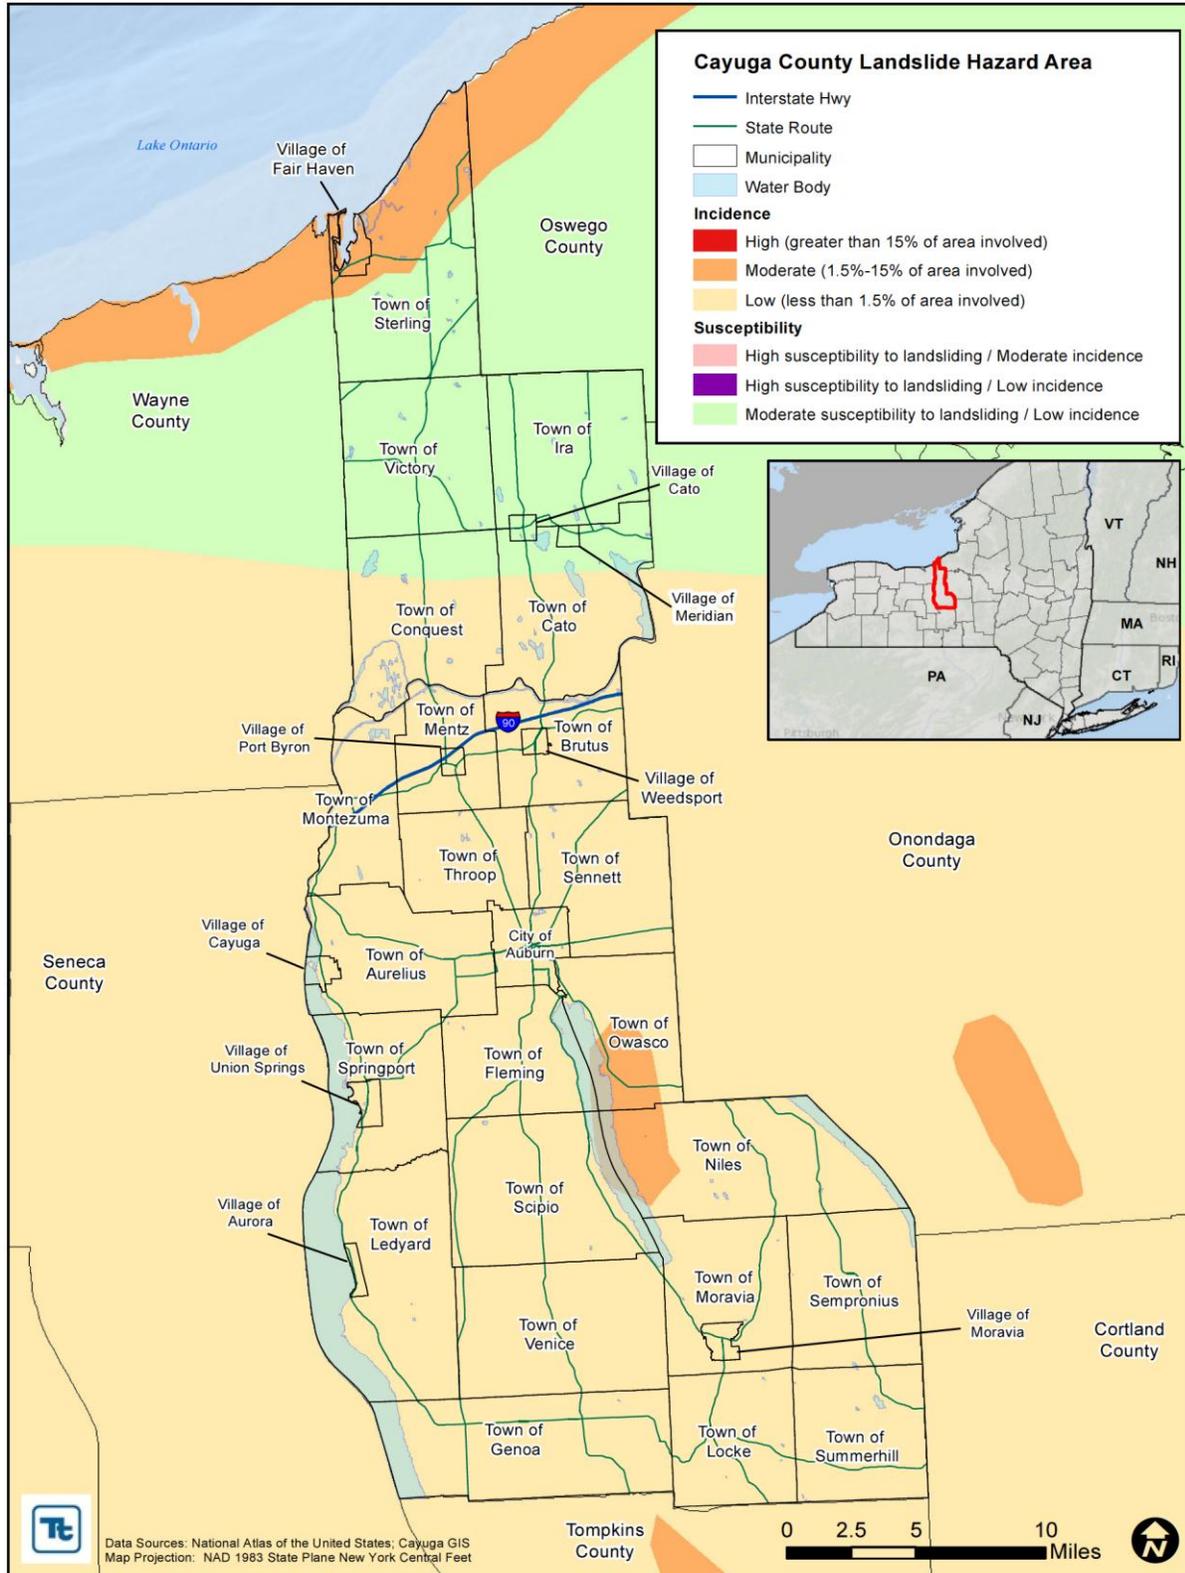
Figure 5.4.2-11 Landslide Hazard Areas in Cayuga County

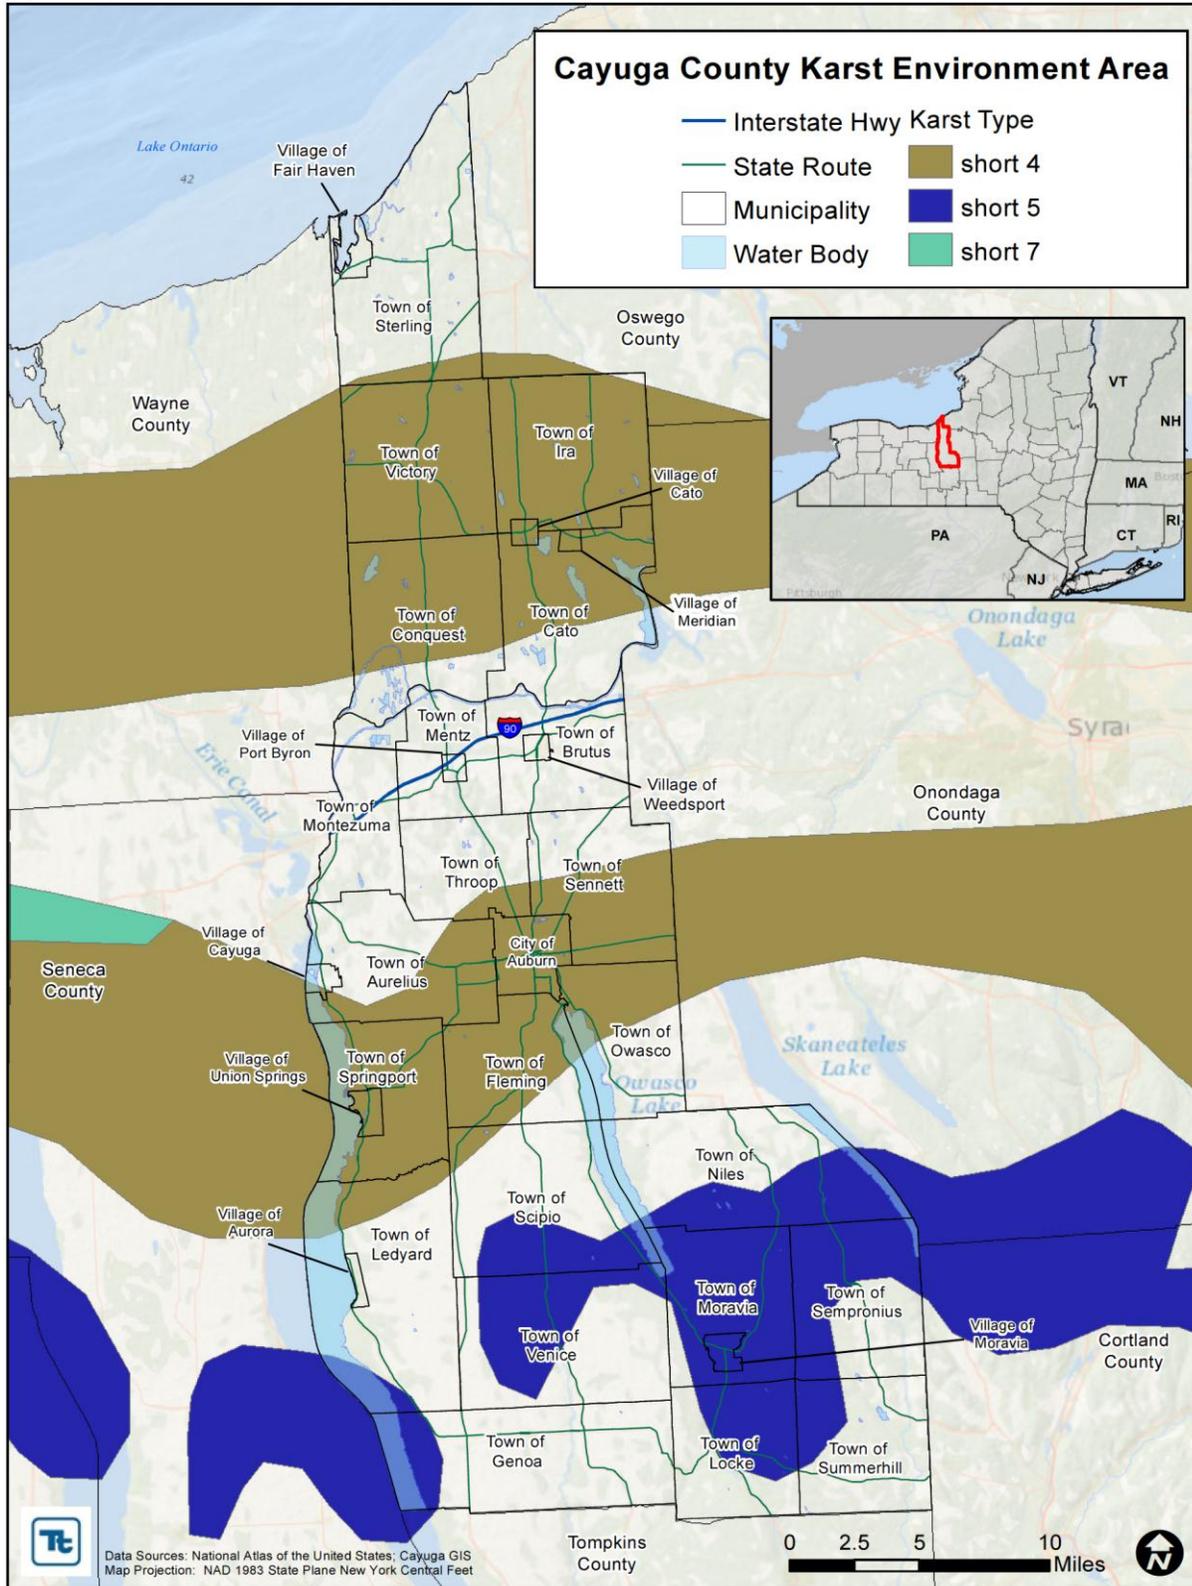
Figure 5.4.2-12 Karst Areas in Cayuga County
